Manhole Inspection Summary

Manhole # S55EE_002MH

Insp Date: **4/18/08 11:37 AM**

Location Address: **Biddle St**

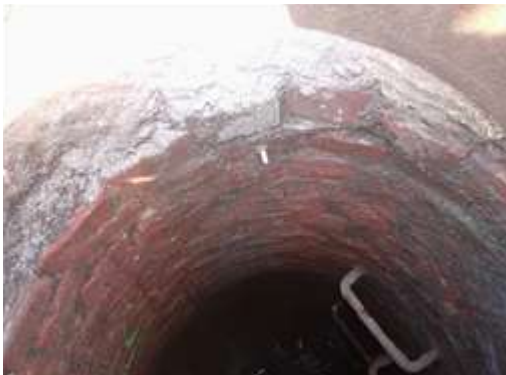
Defect 2

☒ **Leaks**

frame leaks

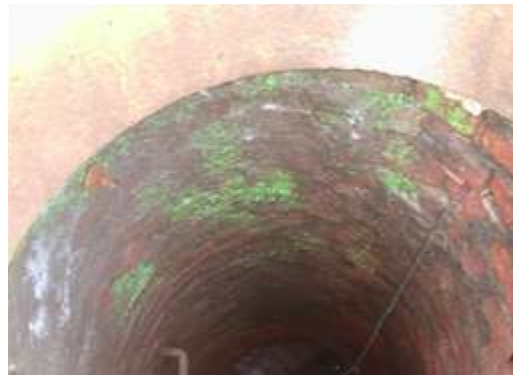
Defect 1

Infiltration: ☐ None ☐ Joint ☐ Cracks ☐ Mortar ☐ Roots ☒ **Wall**

wall infiltration

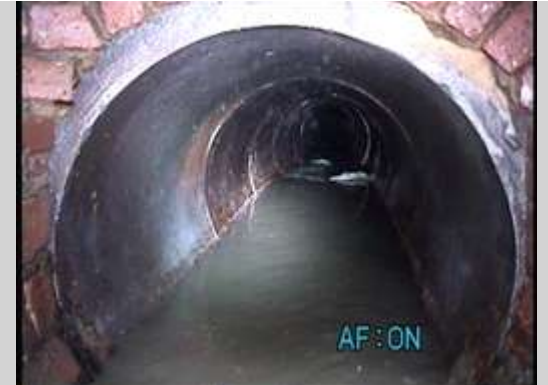
12 O'Clock Outflow

24 in. Circular Gravity Sewer
Pipe Out @ 12 O'Clock

Pipe Height: **24** (in.) Rod and Bar (Angled)
Pipe Material: **Clay** ☐ Pipe Lined
Invert Depth: **12.70** (ft.) Flow Characteristics: **Fast**
Deposits: ☒ None ☐ Mud ☐ Sludge ☐ Debris ☐ Grease
Silt Depth: (in.) Deposits Extent:
Infiltration: **None** Pipe Seal Cond: **Sound**

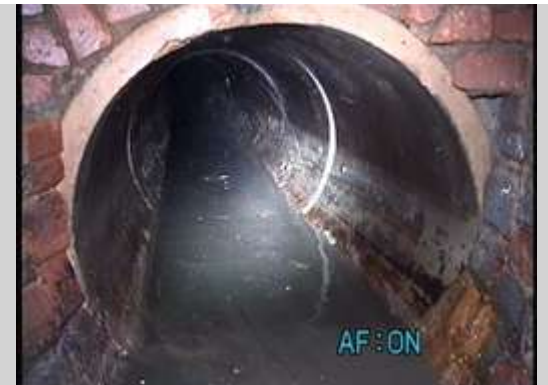
3 O'Clock Inflow

24 in. Circular Gravity Sewer
Pipe In @ 3 O'Clock

Pipe Height: **24** (in.) Rod and Bar (Angled)
Pipe Material: **Clay** ☐ Pipe Lined
Invert Depth: **12.60** (ft.) Flow Characteristics: **Slow**
Deposits: ☒ None ☐ Mud ☐ Sludge ☐ Debris ☐ Grease
Silt Depth: (in.) Deposits Extent:
Infiltration: **None** Pipe Seal Cond: **Sound**

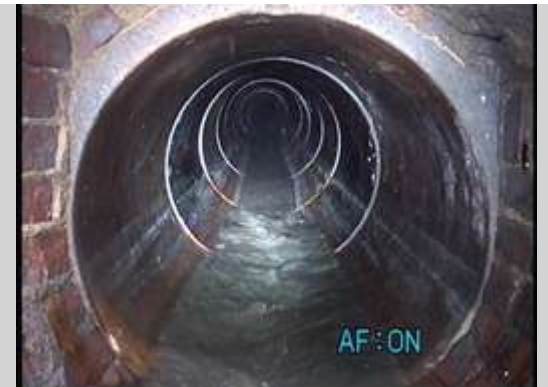
6 O'Clock Inflow

24 in. Circular Gravity Sewer

Pipe In @ 6 O'Clock

Infiltration: **None** Pipe Seal Cond: **Sound**

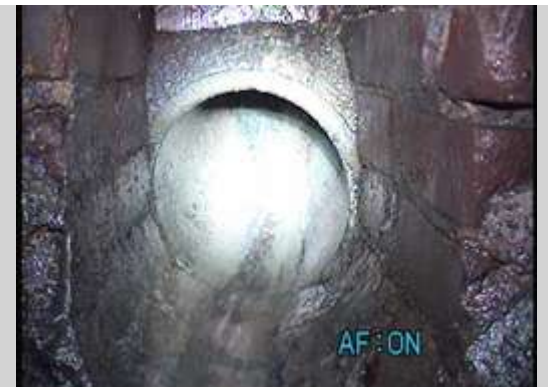
9 O'Clock Inflow

10 in. Circular Gravity Sewer

Pipe In @ 9 O'Clock

Infiltration: **None** Pipe Seal Cond: **Sound**
